Brachial plexus impingement secondary to implantable cardioverter defibrillator: A case report

Case Report

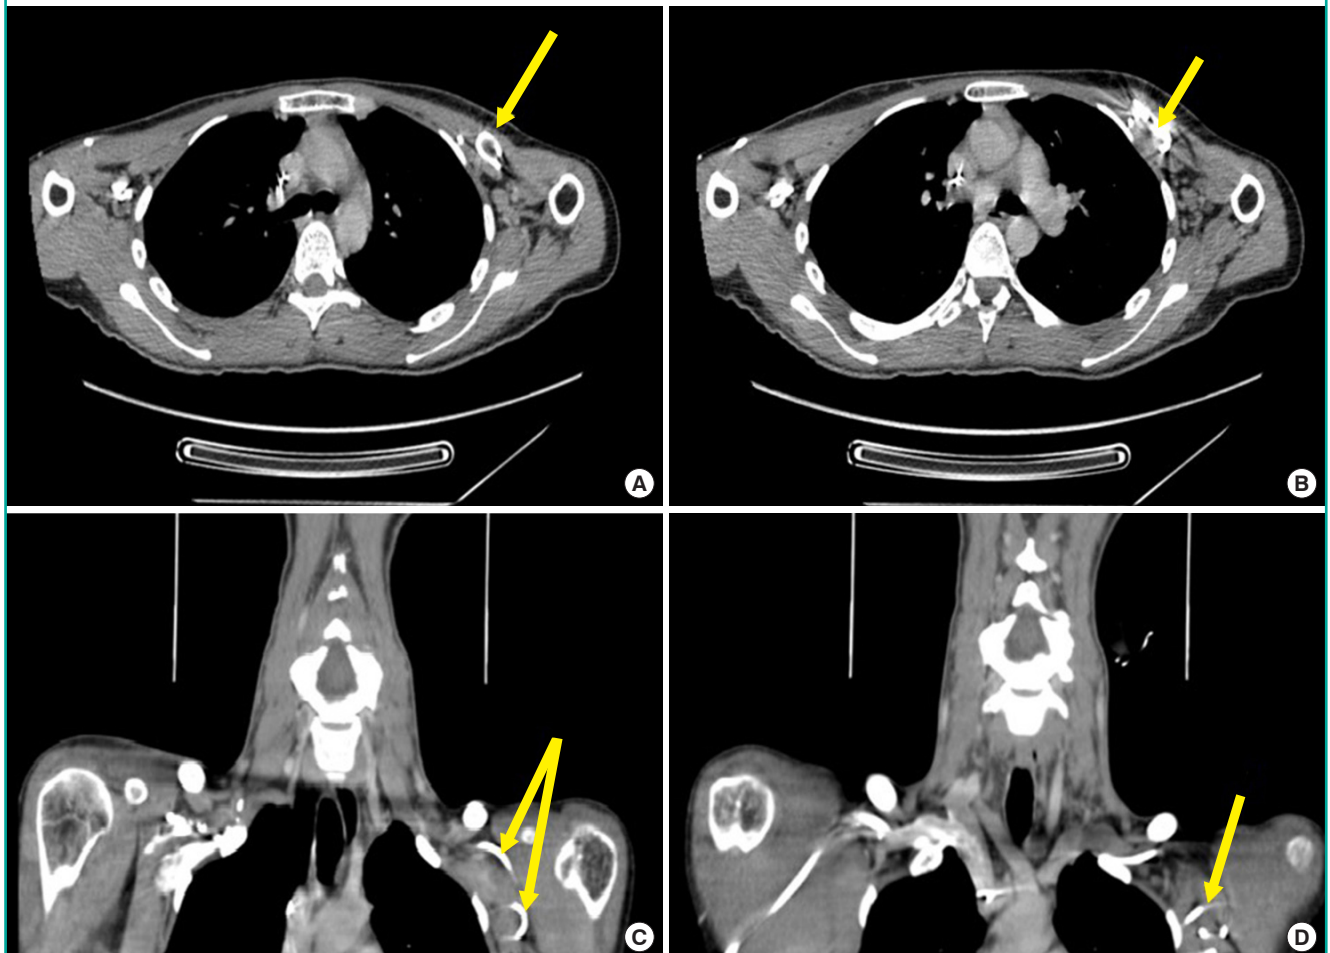
Fig. 1. Contrast neck CT images

Axial plane computed tomography (CT) image. (A) Loop of implantable cardioverter defibrillator (ICD) lead identified in left infraclavicular space (yellow arrow). (B) ICD box identified in left infraclavicular space (yellow arrow). (C, D) Coronal plane CT image. Yellow arrows indicate laterally directed loop lead of ICD in left infraclavicular space.

bus and a computed tomography (CT) angiogram of the neck ruled out a mass lesion as the underlying cause for the brachial plexopathy. Though the CT demonstrated the ICD generator and loop of the ICD lead, it was overall regarded as limited in the evaluation of the brachial plexus involvement (Fig. 1).
